History of Space Shuttle Main Engine Turbopump Bearing Testing at the Marshall Space Flight Center

Howard Gibson, Robert Thom, Chip Moore, MSFC, EM10, Tribology Team Dave Haluck, Pratt & Whitney

JANNAF conference, May 2010

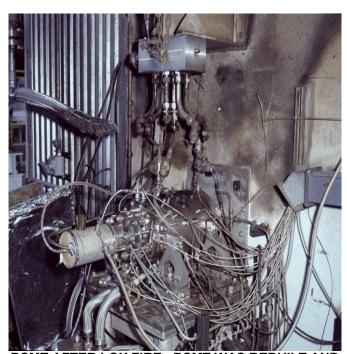
BSMT AFTER LOX FIRE. BSMT WAS REBUILT AND BEARING TESTS WERE RUN IN LN2 FOR SEVERAL YEARS BEFORE RETURNING TO LOX TESTS

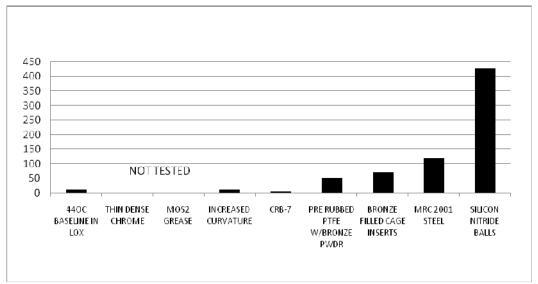
BEARING CAGE WITH BRONZE POWDER/PTFE INSERTS AND BRONZE HOUSING TESTED IN BSMT

- New cage material and design developed by Battelle Labs
 - Bronze powder filled PTFE inserts held in place by a brass housing
 - Insert material not structurally sound to be the entire cage
 - Inserts eliminate glass fibers in the current cage design reduce heat
 - Cages installed into bearings and run in BSMT
 - Bronze transfer film seen on balls after test runs
 - Gained 7X run time in Rocketdyne bearings over standard cage

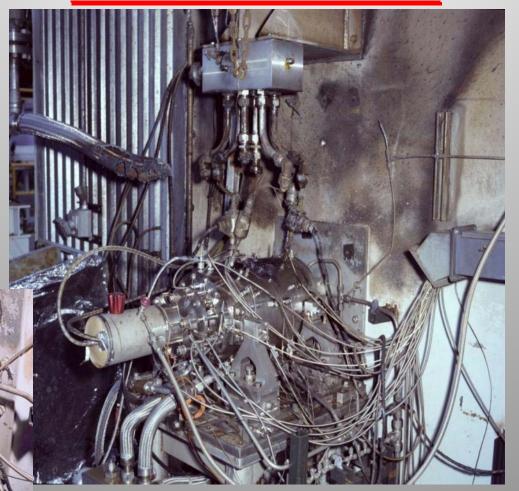
Inconel housing

Loss of coolant thru bearings in one end of rig leads to fire

Stainless steel braided hoses gone, housing burnt thru

Test were run in LN2 before going back to LOX

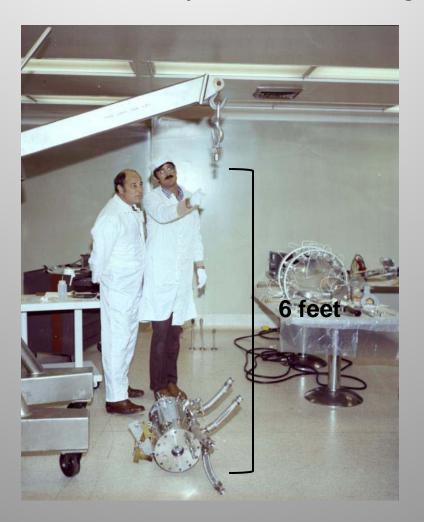
A LOX fire is not the only hazard when building test rigs

BSMT was being spun around for final assembly. Swivel fitting did not work. Eyebolt came loose and rig fell to floor. This build was not sent to test stand.

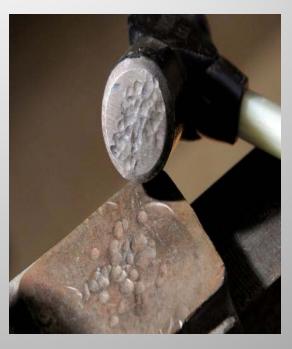
THE 1-1/2 POUND HAMMER TEST!!!

- Took the hammer and ball to program managers and let them take a swing
- One bearing with silicon nitride balls was successfully run in a HPOTP in the TTB!!
- The BSMT bearing tester was retired in 1994 after 12 years of service

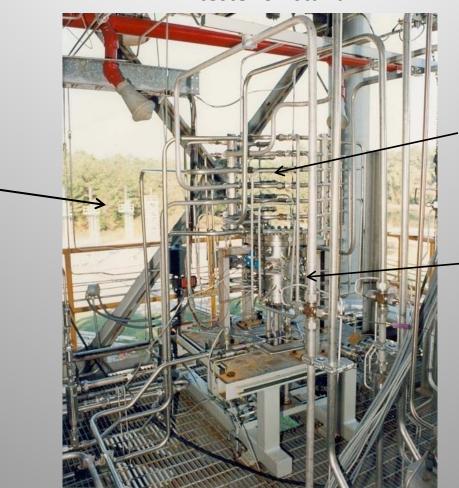
LH2 tester on stand

Inlet and exit tubing above rig for access to instrumentation

Test rig

Hydrogen burn stacks

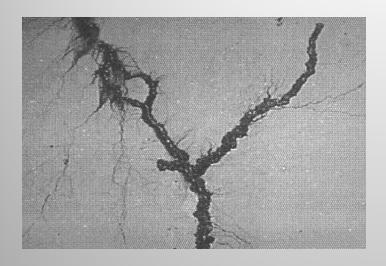
Pre test river mark on ball, Build 5

- Build 5 of LH2 rig, previous tested SiN elements
 - 18 hours of test rig experience, axial shaft control good, no speed issues
 - Went back to roller bearing in test position
 - Attempted runs, had problems again... shaft movement and speed
 - test procedure modified as to when and how much radial load was applied
 - Ran 11 tests for ~3 hours, on 12th run tester shaft would not rotate
 - Roller skewing in cage pockets?
 - Decided to pull rig and inspect
 - No evidence of roller skewing detected
 - Balls had a crazed look on the surface, moderate cage pocket wear
 - Rollers looked good with slight increase in surface distress, some mild rubbing on the ends by cage contact
 - Cage pocket wear moderate

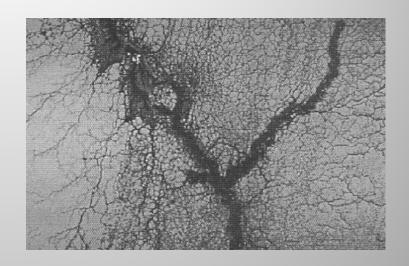
River mark at 3 hours run time

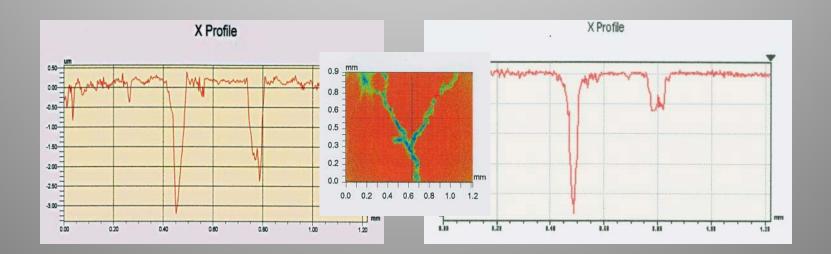
Surface of silicon nitride roller, mark of interest
